HAROLD WEINBERG, B.C.E., M.C.E., P.E.
408 JAY STREET SUITE 301
BROOKLYN, NEW YORK 11201
E-MAIL heshiewein@yahoo.com

January 31, 2013

Re: 229 Exeter St., Brooklyn, NY
UTC #8895

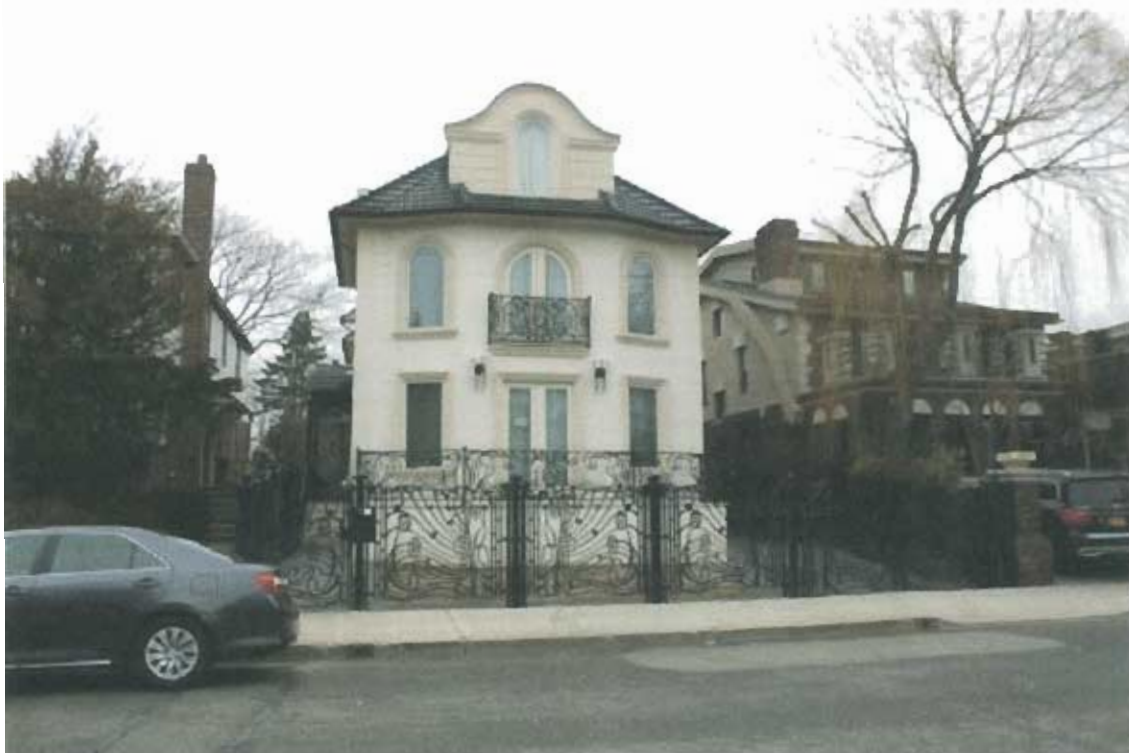
THE FRONT VIEW OF THE PROPERTY

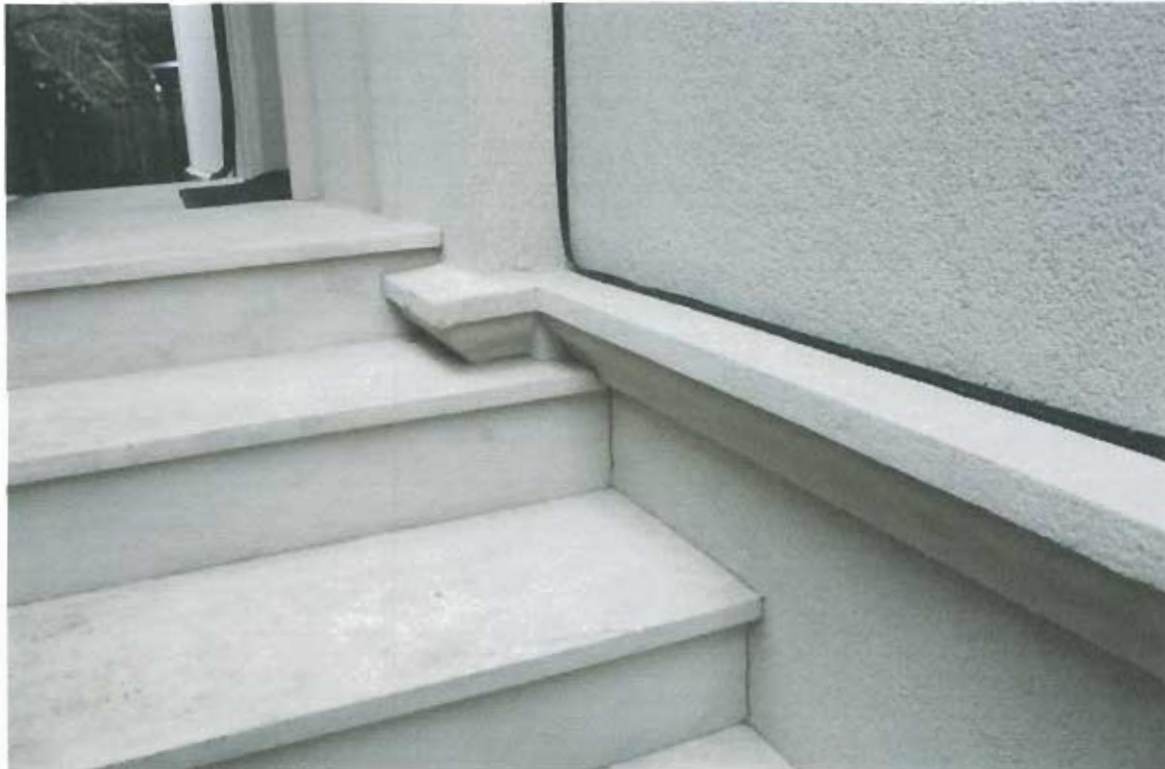
During my examination I examined all the exterior walls and the interior of the cellar space. The limestone walls had cracks at various locations. In addition, the flood waters caused damage to the inside of the building in the cellar. Stairs leading to the first floor and the cellar suffered cracking. Steps were cracked in several places.

EXTERIOR STAIRWAY STEPS CRACKS

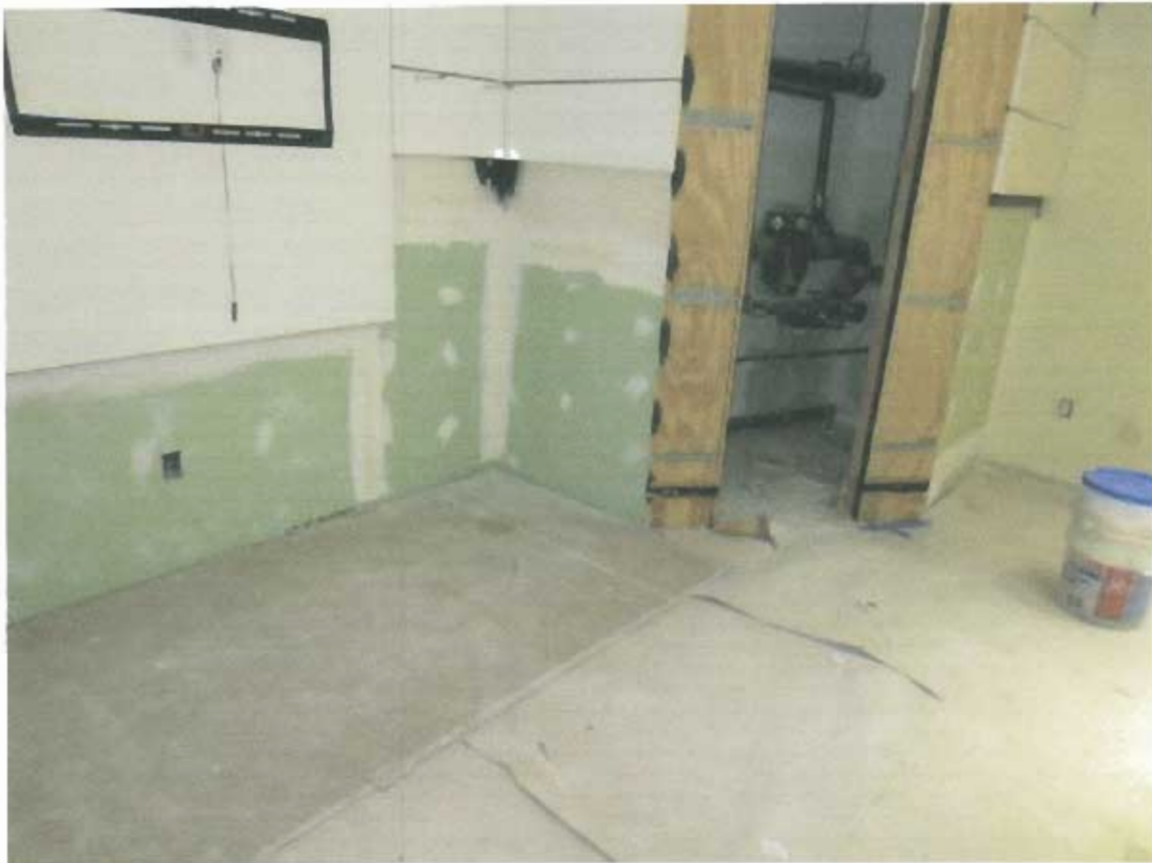
An examination of the exterior water line was made and I determined that the water was at least 36" above the adjacent grade. The damage at the lower part of the building was caused by flooding and is responsible for about 100% in total. The lowest level of the structure is a cellar. The structural system of the foundation walls are masonry block on footings. The entire cellar including the slab finishes and the foundation wall finishes were damaged extensively.

CELLAR AREA DAMAGED UNDER ON GOING REPAIR

I observed that the interior finish of the building that the water level line was also at least 7' high in the cellar. At the time of my visit some rehabilitation had taken place.

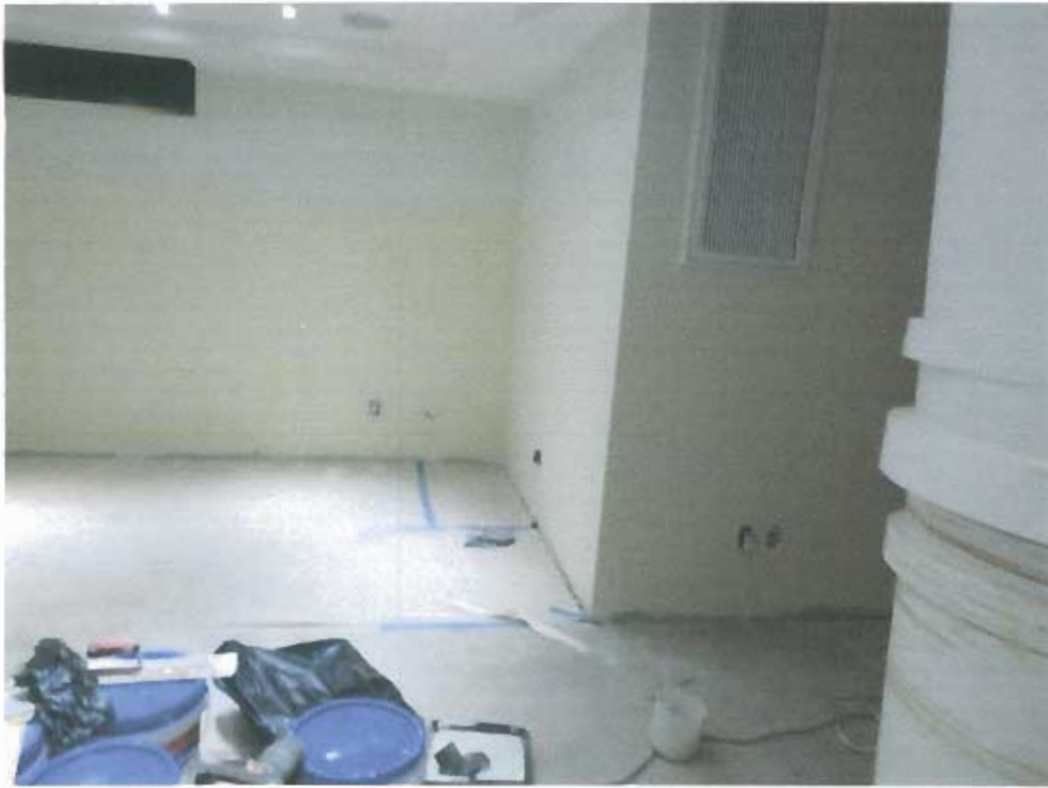
CELLAR ON GOING REPAIR (TYPICAL)

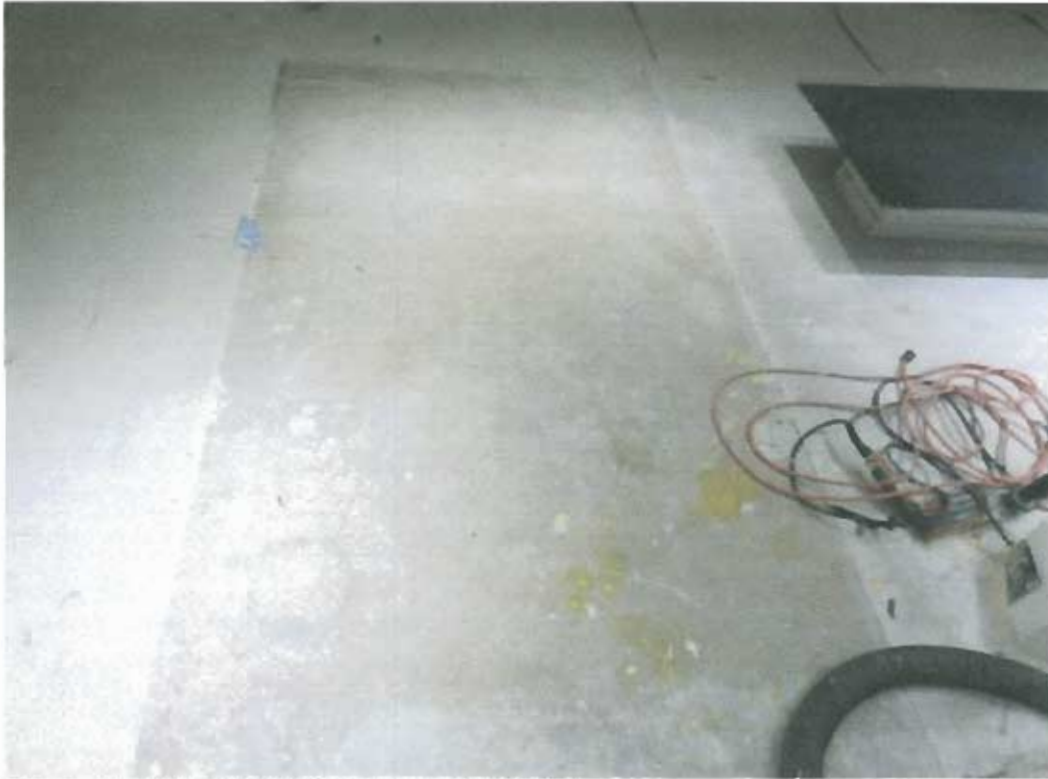
CELLAR ON GOING REPAIR (TYPICAL)

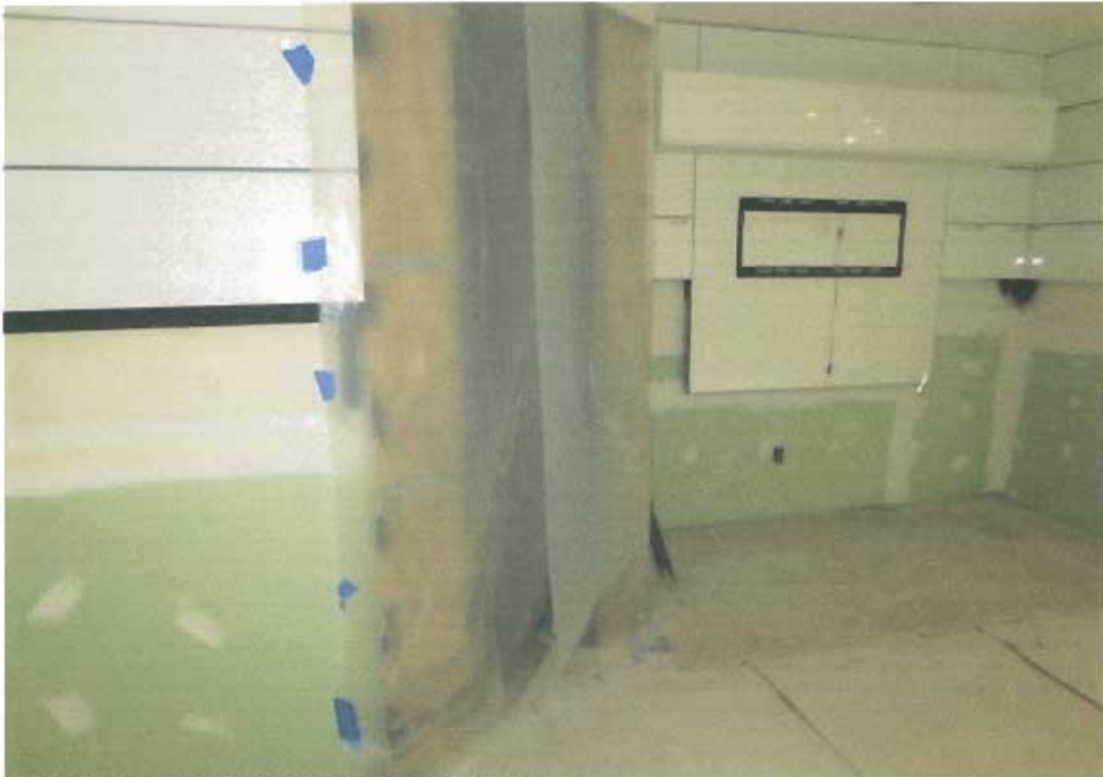
CELLAR ON GOING REPAIR (TYPICAL)

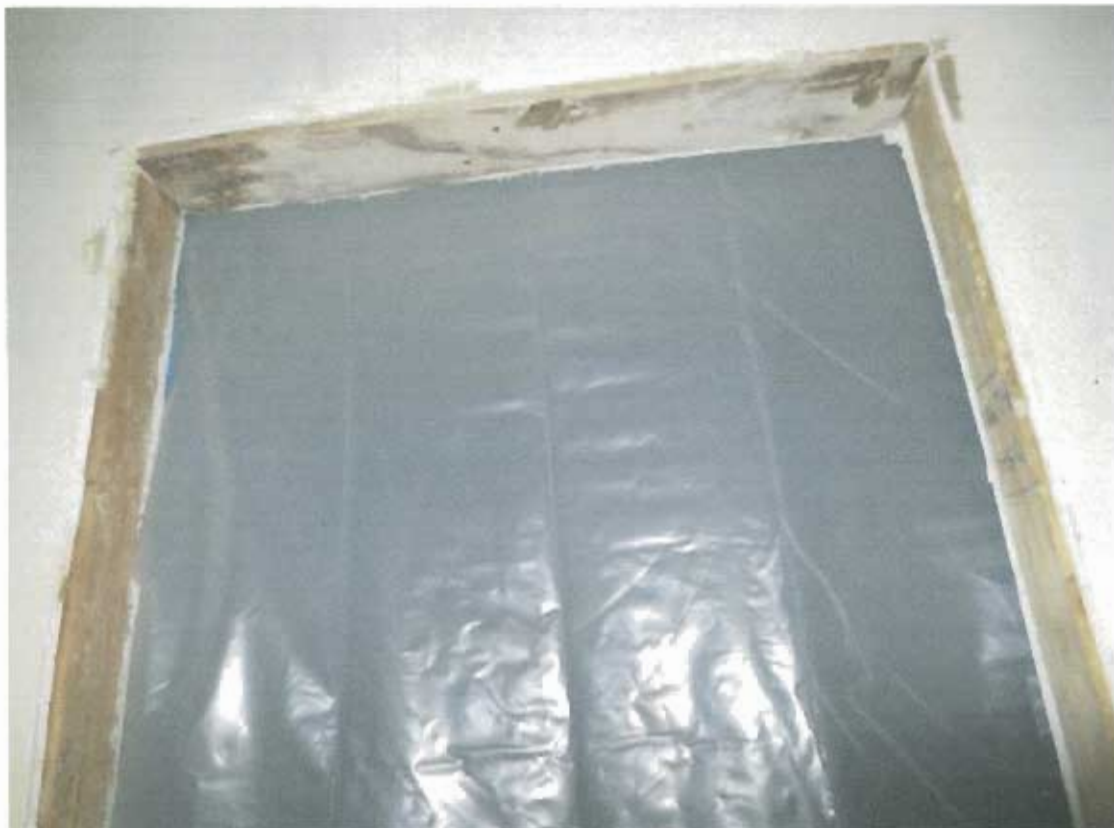
CELLAR ON GOING REPAIR (TYPICAL)

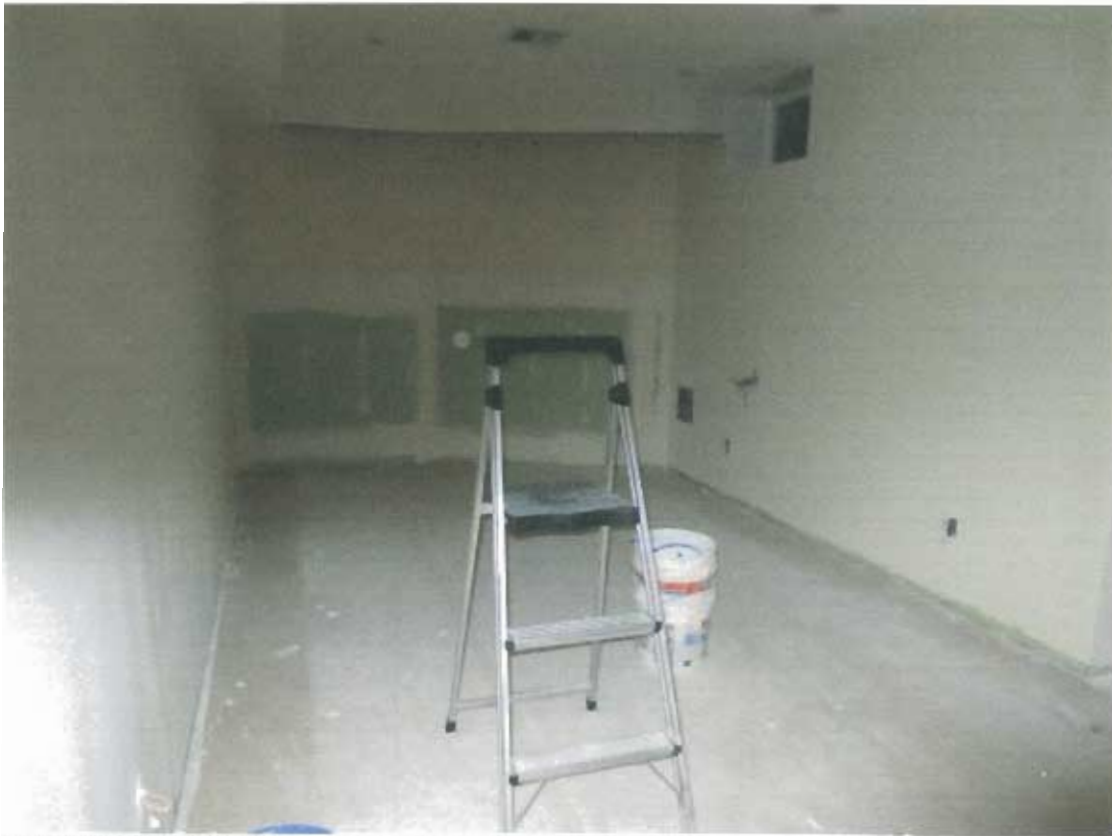
CELLAR ON GOING REPAIR (TYPICAL)

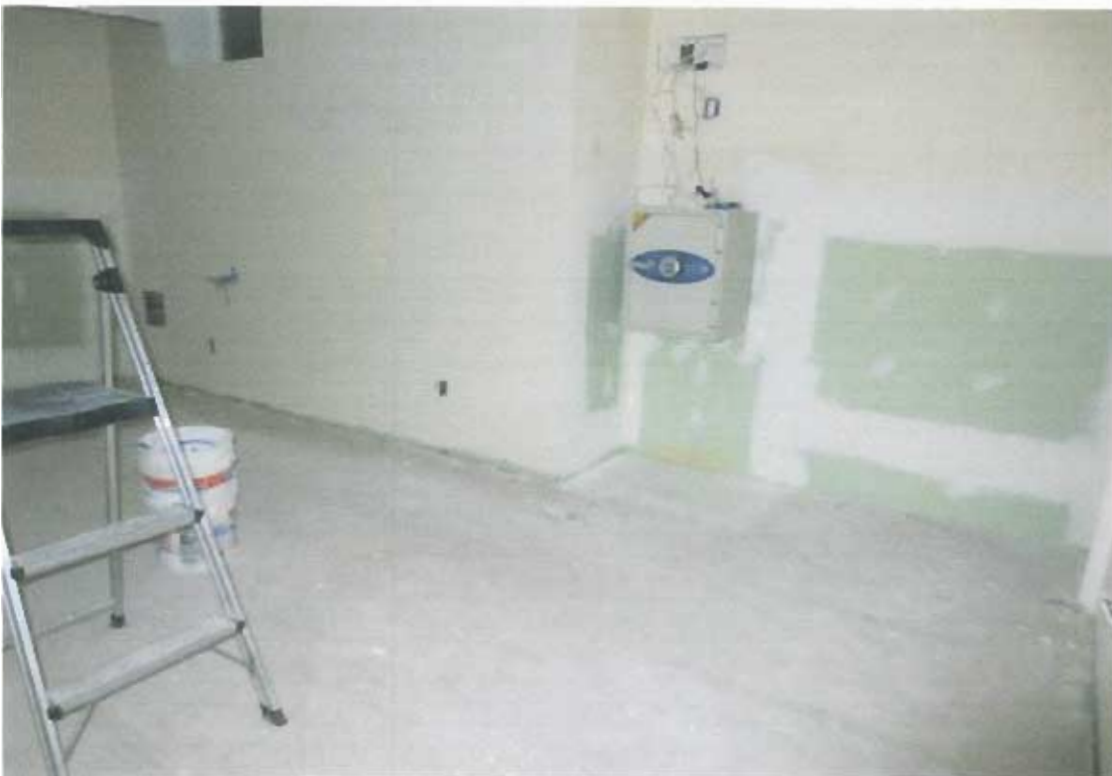
CELLAR ON GOING REPAIR (TYPICAL)

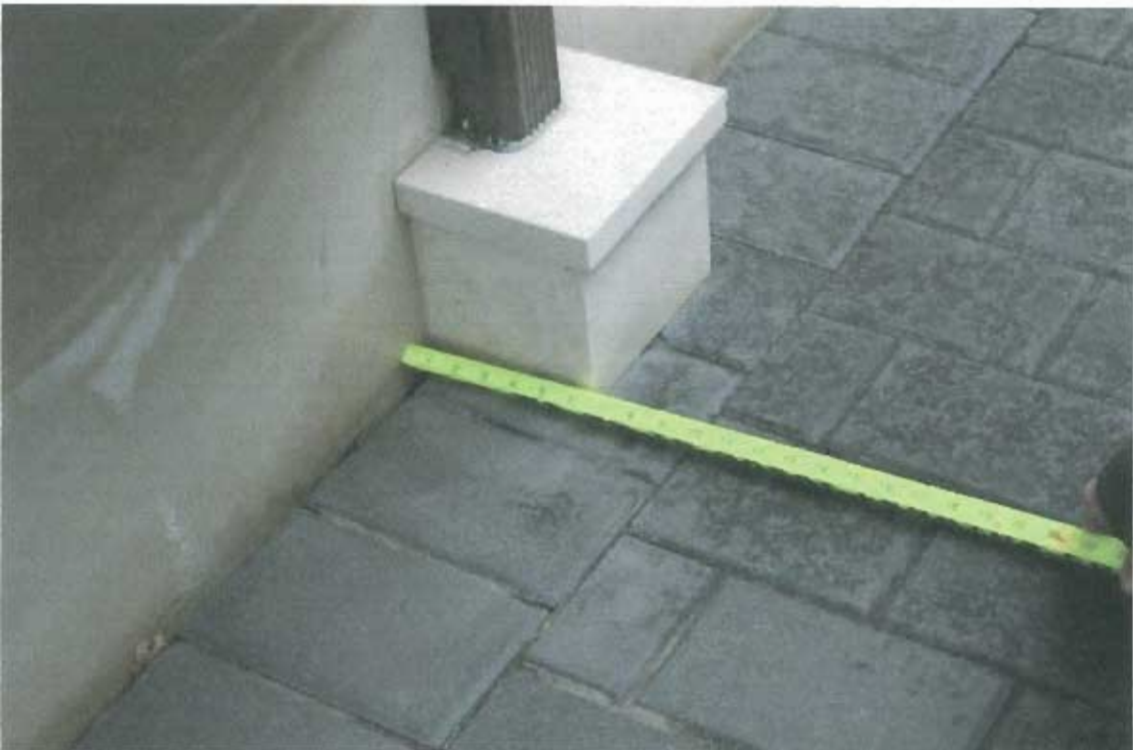
SETTLEMENT & SEPERATION OF EXTERIOR PAVING TO FOUNDATION WALL

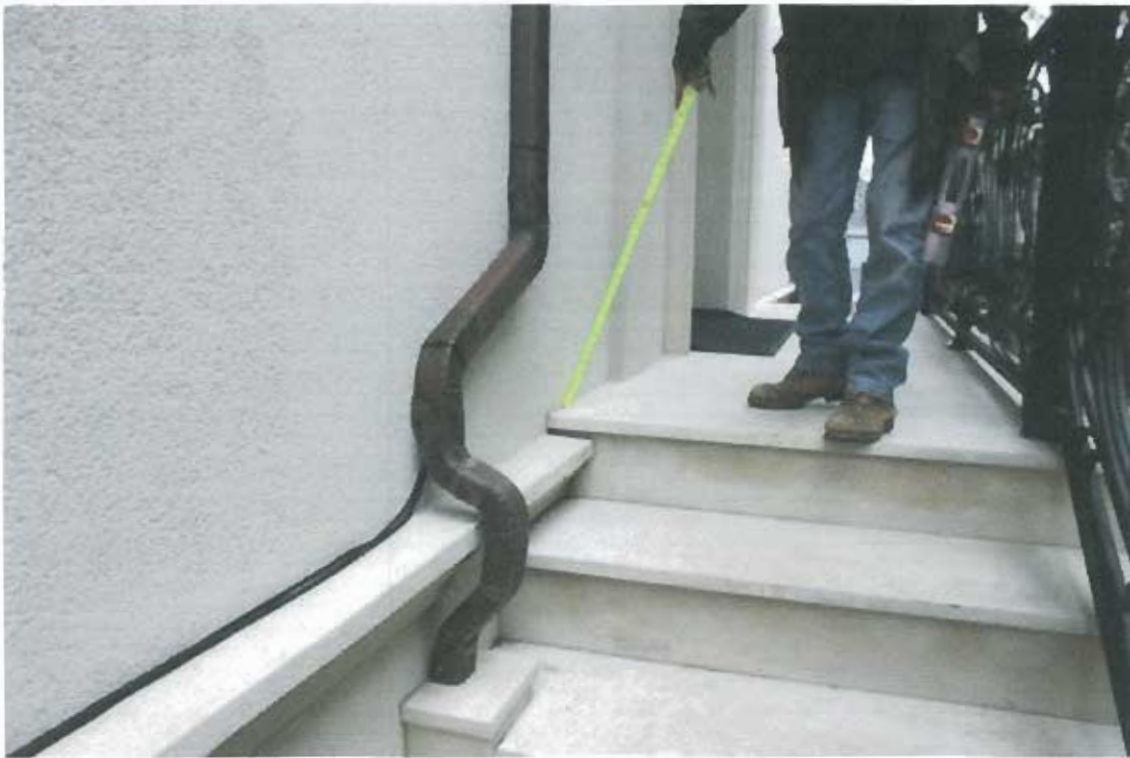
SEPERATION OF STAIRS TO BUILDING WALL

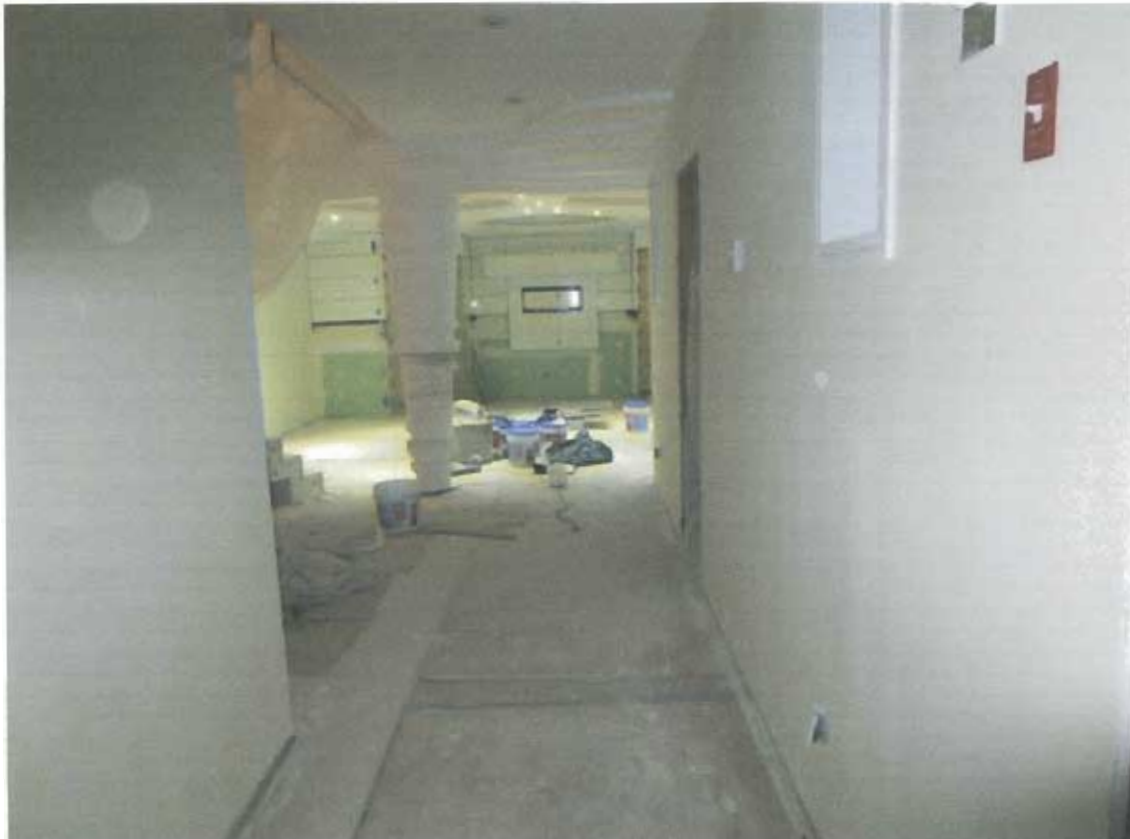
CELLAR ON GOING REPAIR (TYPICAL)
